# Experimental Evaluation of Alternative Low Damage Solutions for Reinforced Concrete Walls

Four half-scale concrete walls with different low damage solutions are currently being tested at the University of Auckland, New Zealand. Low damage alternatives were selected based on literature review and discussion with industry professionals. The first wall has debonded reinforcement encased in steel tubing extended into the foundation, which is intended to trigger a crack at the wall base and distribute the reinforcement strain across the debonded length. In the second wall, steel fiber-reinforced concrete is substituted for conventional concrete throughout the wall, which should allow for increased tensile strain hardening and confinement, but is expected to be lesser when compared to ECC. In the third and fourth wall, ECC is substituted for conventional concrete in the plastic hinge region, which will increase the tensile capacity of the wall and delay deterioration in the hinge region. Higher axial load will be applied to the fourth wall relative to the third to observe the impact fibers have on confinement.

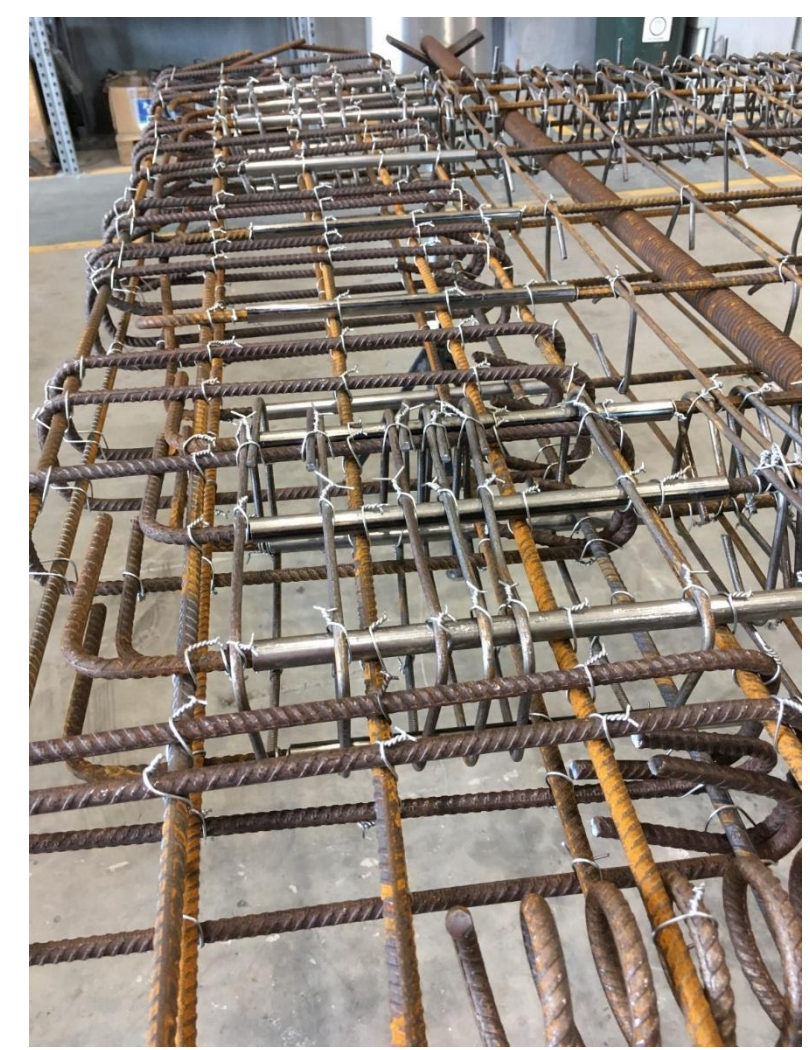
Close up of debonded tubes in the foundation.

- Location of Debonding: Foundation
- Length of Tube: 300mm
- Material of Tube: Grade 400E Steel
- Thickness of Tube: 3mm

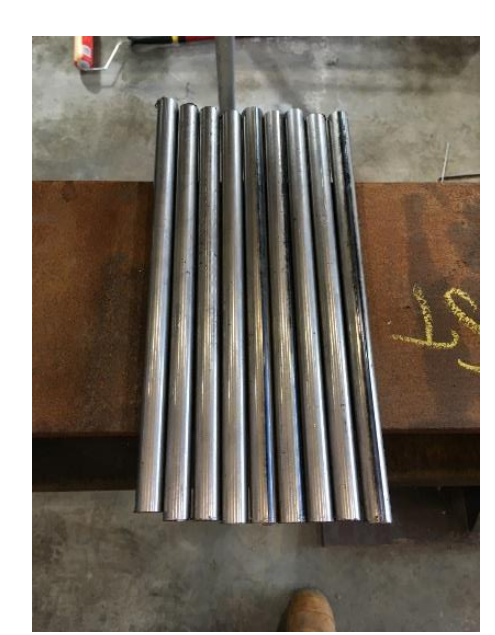
Steel debonding tubes.

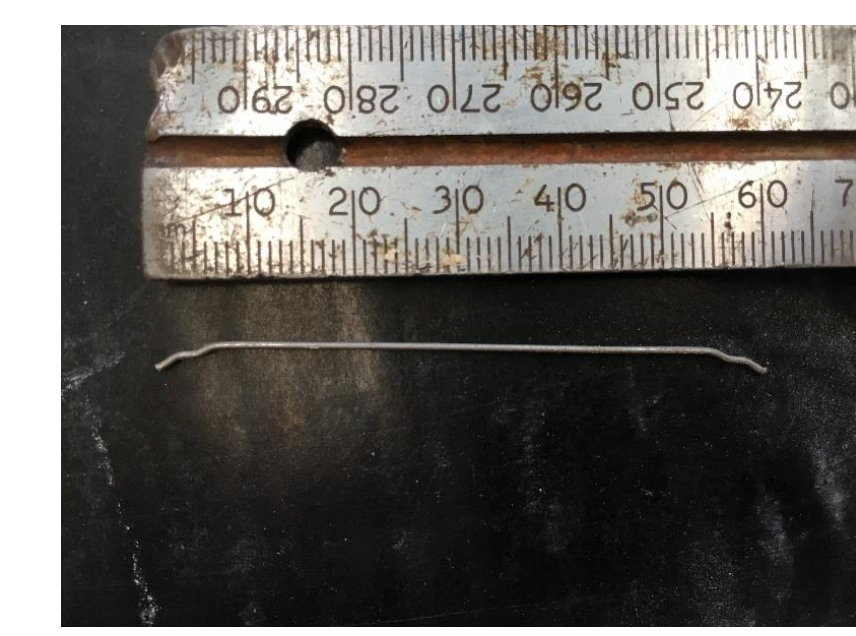
Profile view of a steel fiber.

- Steel hook fibers
- 80kg of fibers per 1m<sup>3</sup> of concrete
- 3.33% fibers by weight

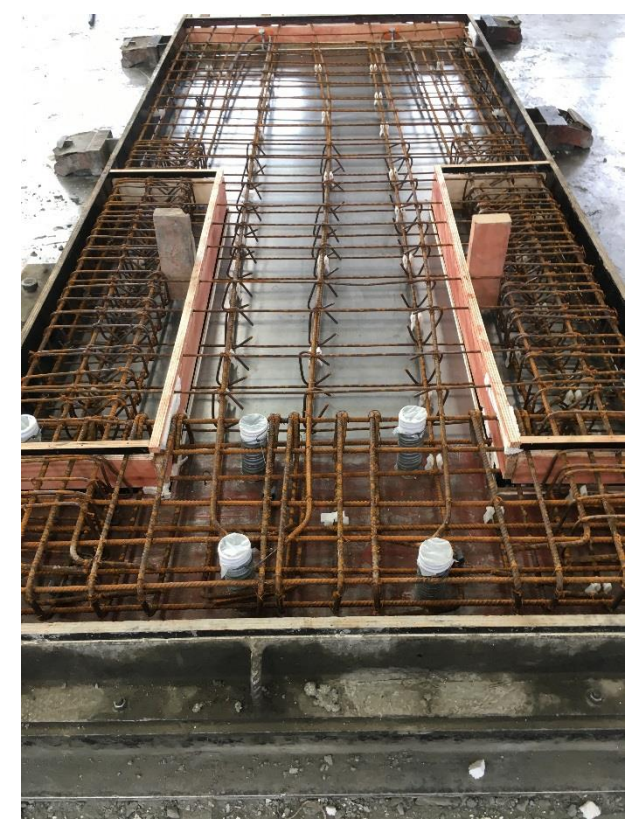
Formwork for ECC sections.

- Above Foundation: 1.1m x 0.363m x 0.15m
- Inside Foundation: 0.15m x 0.636m x 0.15m

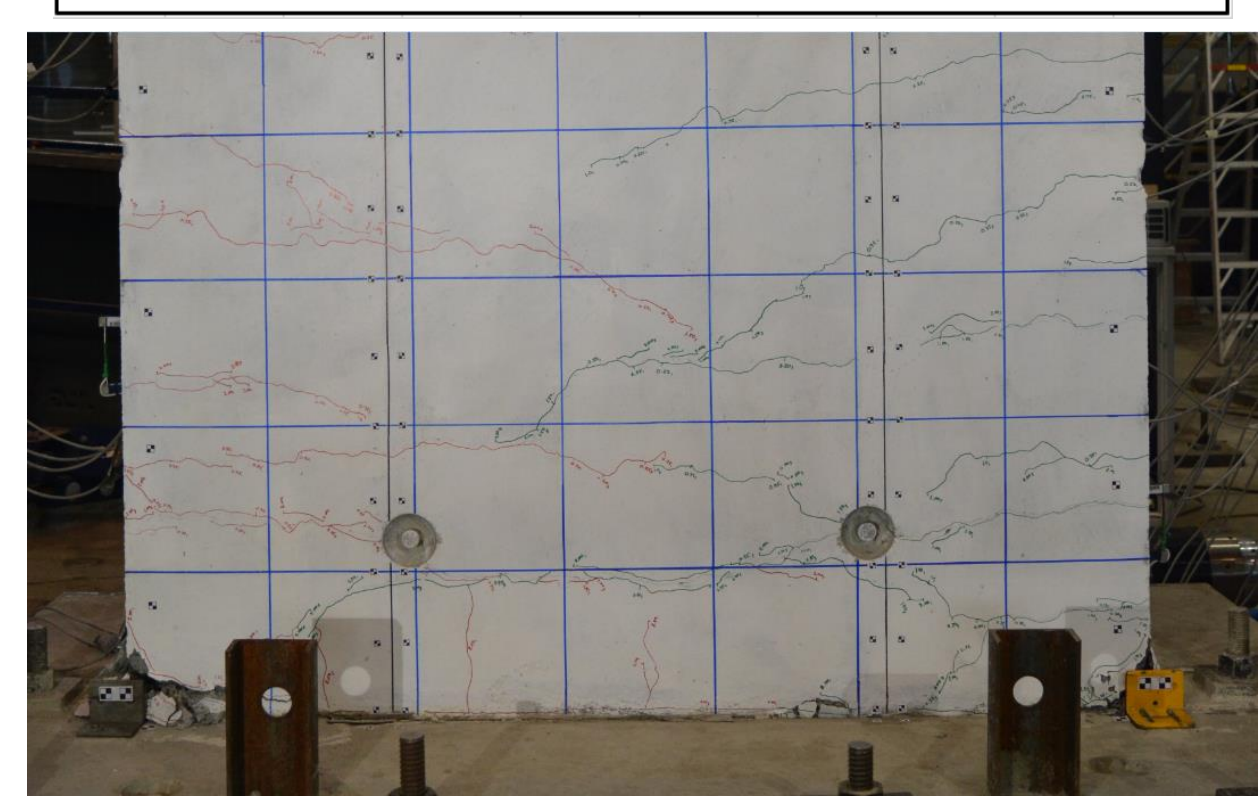
Base crack at 2.5% drift (cycle 29.00).

- Base crack opened at 0.25% drift
- Crack localization at 1.0% drift
- Bar buckling at 2.0% drift
- Bar fracture 2.0% drift
- Debonding tube buckled
